AN INVESTIGATION ON HYDROLOGICAL FAILURE IN CULVERTS AT AJEGUNLE-EGBEJILA ROAD AND COCA-COLA ROAD, ILORIN

+K.O Olorunfemi and *M. R. Baiyeri.

⁺Department of Civil Engineering Kwara State Polytechnic, Ilorin, Nigeria.*Department of Agricultural and Bio-Env. Engineering Technology, Kwara State Polytechnic, Ilorin, Nigeria

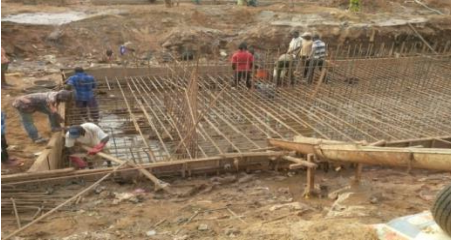
Plate 1. Arrangement of reinforcement bar

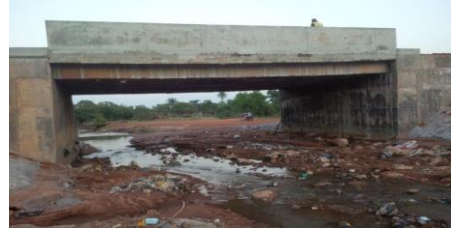
Plate 2. The new constructed bridge at Ajegunle-egbejila road.

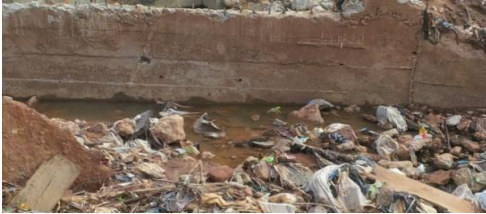
Plate 3. Dumping of accumulated refuse at coca-cola road, Ilorin.

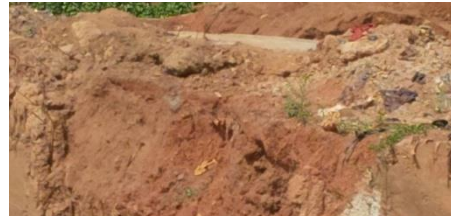
Plate 4. The collapsed culvert located at coca-cola road, Ilorin

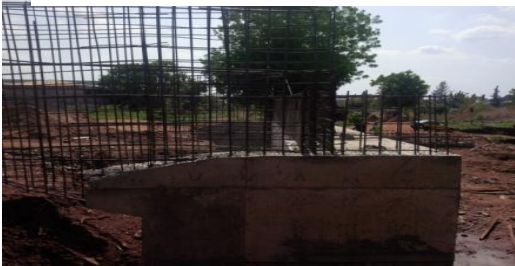
plate 5. the on-going construction of the bridge at coca-cola road.

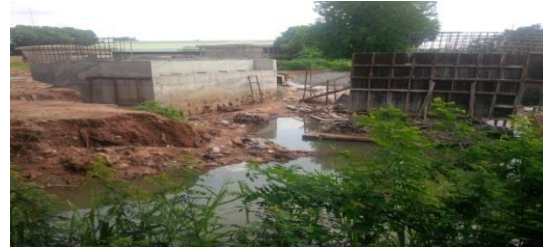
Plate 6. the on-going construction of bridge at coca-cola road.

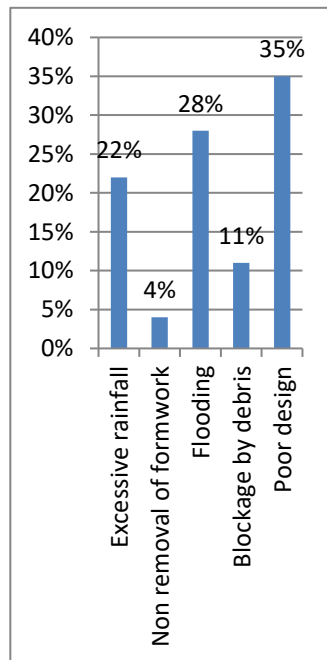
The outcome of the questionnaires analyzed in Figure 1 to 4 shows that poor design are the major cause of hydrological failure in culverts while lack of accessibility is the effect at Ajegunle-

Figure 1: Causes of hydrological failure at Ajegunle-Egbejila road, Ilorin.

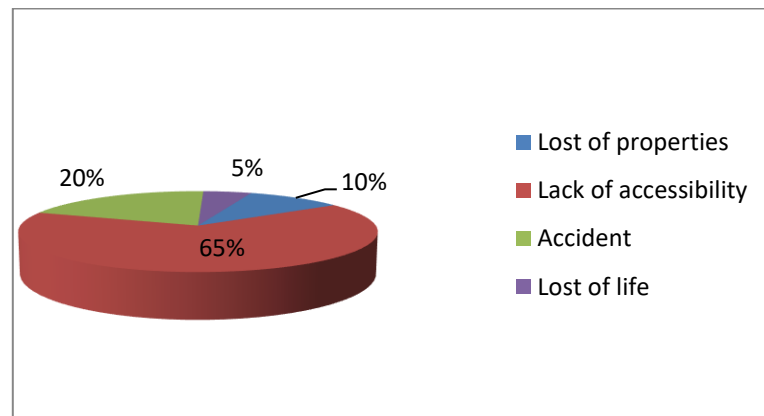
Figure 2: Effect of hydrological failure in Ajegunle-Egbejila road, Ilorin

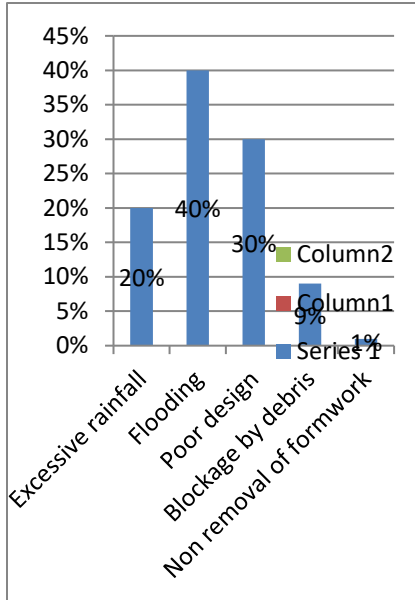
Moreso, flooding is the major cause of hydrological failure in culverts at coca-cola road, in Ilorin and lack of accessibility is the major effect.

Figure 3: Causes of hydrological failure of culvert in coca-cola road, Ilorin

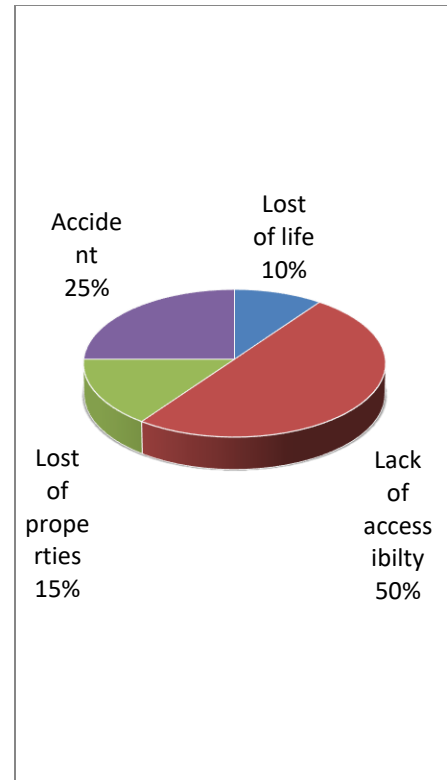
Figure 4: Effect of hydrological failure in coca-cola road, Ilorin
